Restoration of Hardwood Creek

Project # 00-214

**Heather Enterline
U.S. Fish & Wildlife Service
Alpena Fishery Resource Office
Alpena, MI
January 2001**

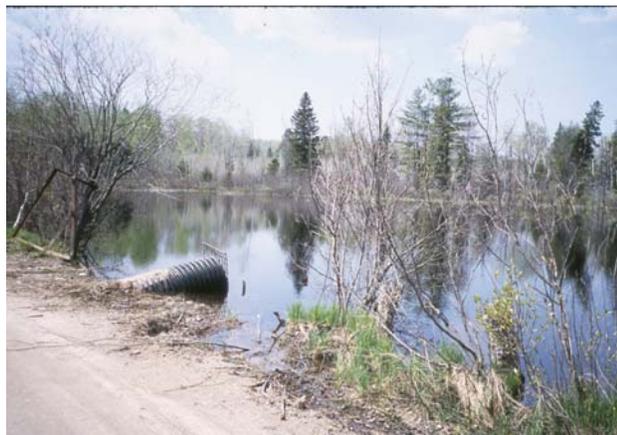
Figure 2. Hardwood creek with plastic culvert. Notice the culvert is floating. April 1998

The culvert acted as a fish passage barrier. The downstream side of the culvert was perched, making it impossible for brook trout or any other fish to move upstream. A grate placed on the intake side of the culvert to thwart beaver activity not only did not slow the beaver but also acted as a “trash rack” collecting floating debris and not allowing woody debris to pass downstream. This added to the ineffectiveness of the culvert.

National Fish & Wildlife Foundation (NFWF) funding allowed for the U.S. Fish and Wildlife Service (Service) and partners to remove the plastic culvert and replace it with a 6'8" x 4'8" x 30' wooden box culvert. The culvert was made in Michigan utilizing red pine harvested in Michigan. A wooden culvert was chosen to accommodate aesthetic concerns as well as cost and functionality. The box culvert allows for fish passage, can accommodate a 50-year flood, and allows the stream to regain unimpeded flow.

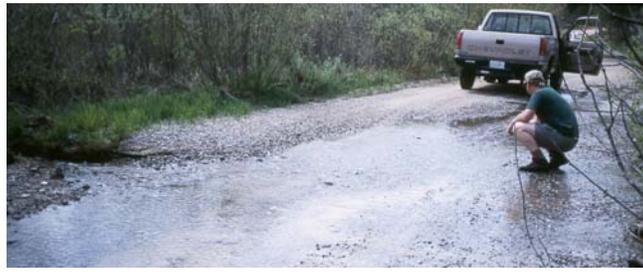
The plastic culvert caused a number of physical and biological impediments to Hardwood Creek. The first and most obvious impediment was that the culvert restricted flow in the creek, and backed up the water to create an impoundment. The road acted as a dam, and during events of high precipitation the water would crest over the road and wash silt, sediment, and gravel into the creek. Gravel, sand and silt from the road were evident over ½ mile downstream from the road crossing. This excess sediment loading altered the hydrology of the stream filling pools, riffles, covering large woody debris, and created a stream habitat with little variance. The shallow impoundment created by the culvert acted as a silt trap, and warmed the water. Warmer water decreases the amount of dissolved oxygen available to aquatic organisms, and can warm the stream to a point where temperature-sensitive brook trout are unable to live.

Figure 3. Hardwood Creek washing over the road, April 1998

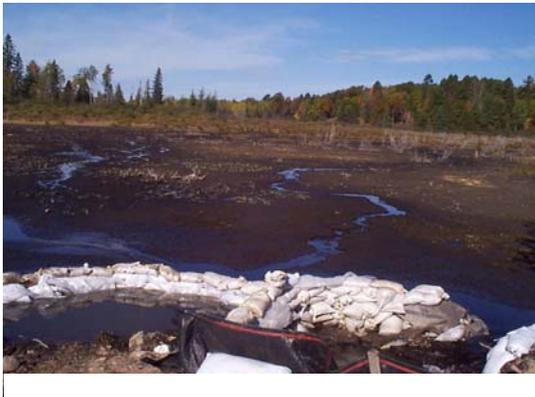
Figure 4. The drained impoundment, Oct. 2000

Construction on the Hardwood Creek/Chandler Dam Rd. crossing began in early September, and ended with the placement of the culvert the first week of October. In early September a temporary culvert was placed to drain the impoundment and to act as an alternate outlet for the creek during the placement of the wooden box culvert. The impoundment was drained slowly to reduce erosion, and by the end of September the site was ready for culvert replacement. The old culvert was removed, a new base was set, filter fabric was placed, and the four sections of culvert were placed and aligned by

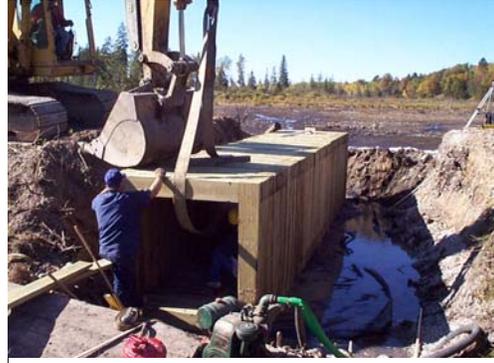
Figure 5. Lining up sections of the box culvert, Oct. 2000

Lowshaw Brothers' crane. Lowshaw Brothers gave a 50% discount of their usual rates due to the environmental nature of this project.

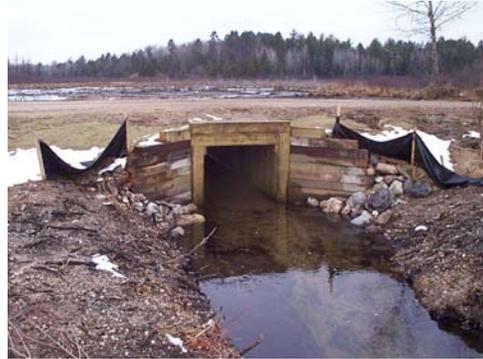
**Figure 6. The completed culvert,
Nov. 2000**

Restoration of this road/stream crossing has alleviated all biological impediments caused by the former culvert. The wooden box culvert compensates for a 50-year storm event, and allows the creek to once again flow freely. The former reservoir will have extensive new growth by early summer 2001, and revert into a non-forested wetland. This
