# Upper Black River Road Crossing Restoration

## Tin Shanty Bridge

Report Submitted to:  
National Fish and Wildlife Foundation

Project # 99-279

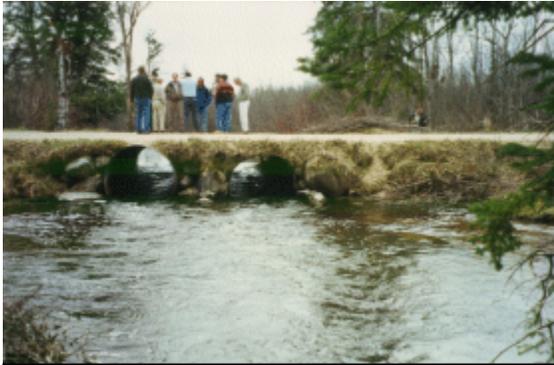
**Figure 1. Tin Shanty Bridge, before restoration**

partnered and pooled their funding to restore Tin Shanty Bridge. Concern had grown by local groups because this road/stream crossing was a large source of sand and silt pollutants into the watershed. The two culverts at the crossing acted as fish passage barriers as well (see Figure 1). The Upper Black River is renowned throughout Michigan as containing an excellent native brook trout fishery. The high sediment loads coupled with the lack of fish passage made the restoration of this road/stream crossing a high priority for all involved parties.

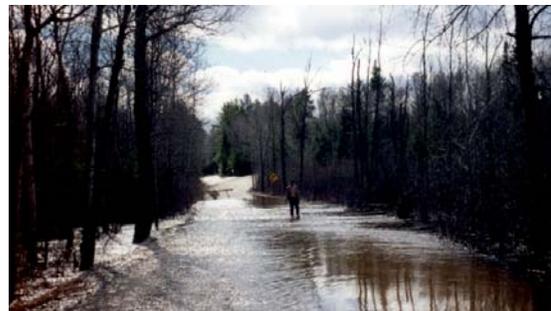
There were a number of problems that contributed to the sediment load in the stream and the blocking of fish passage. Due to inadequate culvert size this sand/gravel road periodically washed out during high water events (see Figure 2). The sand and silt from the road washed directly into the river, contributing several tons of sediment to the watershed with every incident. Sediment filled in several river-miles of brook trout spawning habitat, located directly downstream from the road/stream crossing. The culverts were also fish passage barriers to a native strain of brook trout. Spawning habitat is located both upstream and downstream of this road/stream crossing. The culverts were perched. Perched culverts mean that the culverts were not properly placed in the streambed. Downcutting resulted on the downstream side of the culverts, making fish passage from the downstream side challenging if not impossible. The restrictive size of the culverts backed up water, warmed it, and created an accelerated flow through the culverts to compensate for the size restriction. These factors effectively blocked fish passage.

**Figure 2. Before restoration the road would wash out.**

Restoration of Tin Shanty Bridge has alleviated the restriction in the river, allowing the river to regain its natural flow rates and natural stream bed, it no longer blocks fish passage, and the bottomless span compensates for 50 year storm events.

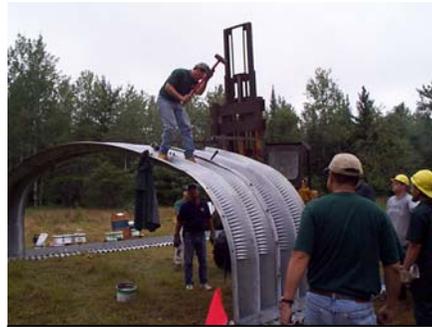
The "bottomless culvert" (bridge) was purchased from St. Regis Culvert, Inc., and was delivered the week of August 9<sup>th</sup> to an assembly site ¼ mile north of the road/stream crossing. The bridge came unassembled. Pieces fitted together with large nuts and bolts like a Tinker Toy from childhood days (see Figure 4). A forklift from the Otsego Road Commission was utilized to position the pieces during assembly. The Michigan Civilian Conservation Corps (MDNR) were the majority of the workers present, and members of the road commission and a representative from St. Regis were on-site at all times to supervise. The bridge was fully assembled in two days.

**Figure 4. Assembly of bridge**

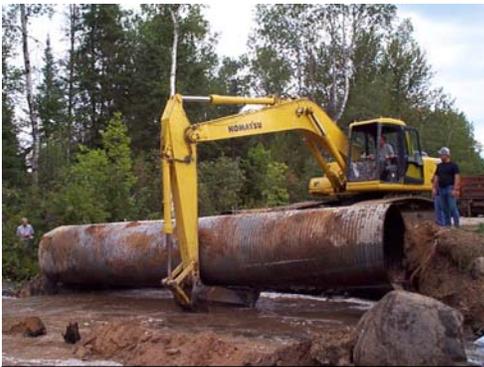
**Figure 5. Culvert removal**

Once the bridge was on-site the excavator began culvert extraction. Water was diverted through one culvert as the other (culvert) was removed.

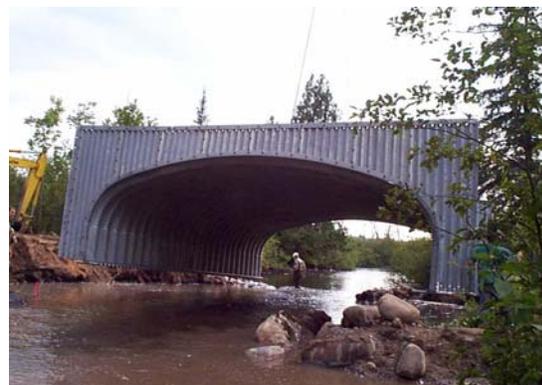
After the first culvert was removed the excavator leveled the area where the steel footings for the bridge would be placed. Removal of the second culvert soon followed, footings were leveled, and by 6:00PM the crane prepared to place the bridge. The bridge was placed and properly angled with the river by 7:30PM.

**Figure 6. Placement of bridge by crane**

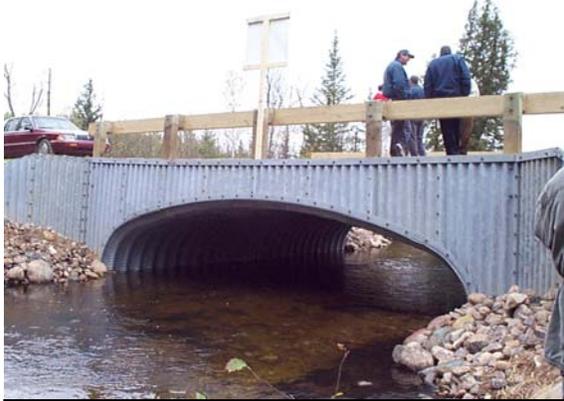
The Otsego Road Commission placed the wing-walls and placed the fill over the bridge for the next two days. Rock rip-rap was placed by the Upper Black River Watershed

**Figure 7. Tin Shanty Bridge after restoration**

Restoration Committee against the wing-walls and along the footing to assist with stabilization of the structure. The Montmorency County Conservation Club hired a work crew of college students to assist the road commission, and to do the final seeding and “clean-up” of the site. The water levels of the river were so restricted by the former culverts, that by August 24<sup>th</sup>, the day after culvert removal, the river levels above the bridge had

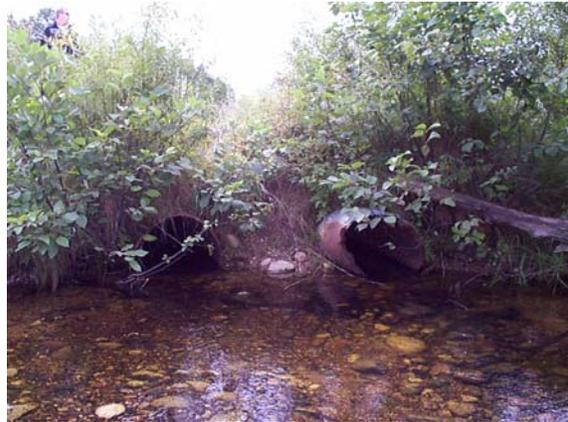
**Figure 9. Road/Stream crossing impeding Tomahawk Creek. The culverts are barely functional.**
